# PETERSEN ALUMINUM CORPORATION TEST REPORT

ASTM E330-14 TESTING ON 0.032" ALUMINUM FSP-12 FLAT SEAM PANELS

H6811.02-450-44-R0

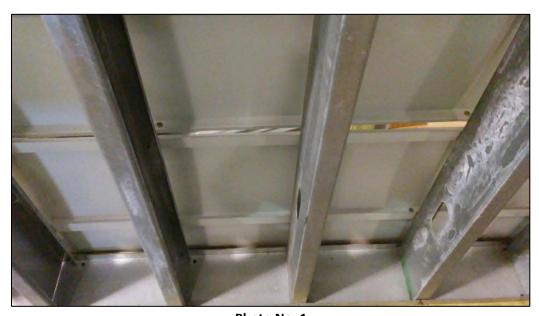
Photo No. 1 Specimen #1 Failure Mode

- Note 1: Loads were held for 10 seconds.
- Note 2: Tape and film were used to seal against air leakage during structural testing. In our opinion, the tape and film did not influence the results of the test.
- Note 3: Panels separated, screws securing panels to each other pulled out.
- Note 4: Panels pulled away from installation screws.

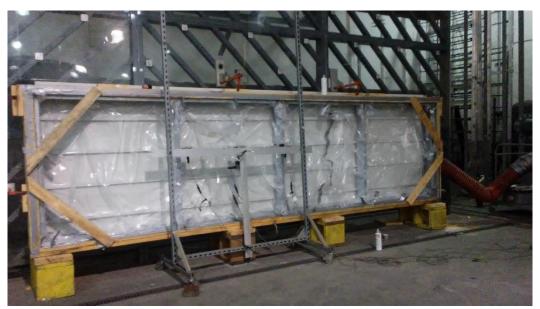
Photo No. 2 Specimen #2

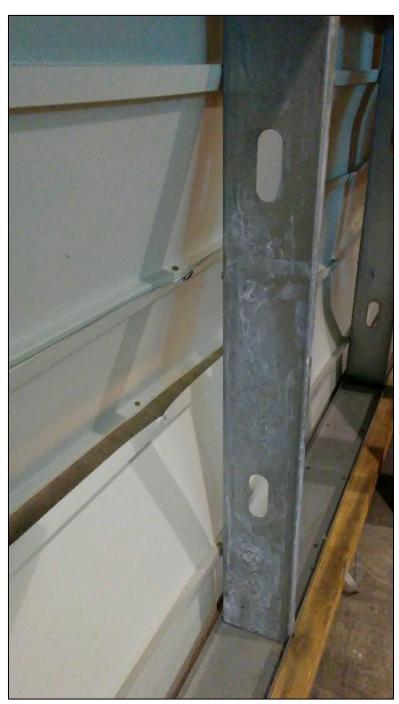
Photo No. 3 Specimen #2 Failure Mode
